NACA RM E53G02

PRELIMINARY INVESTIGATION OF SEVERAL ROOT DESIGNS FOR
CERMET TURBINE BLADES IN TURBOJET ENGINE

II - ROOT DESIGN ALTERATIONS

By A. J. Meyer, Jr., G. C. Deutsch, and W. C. Morgan

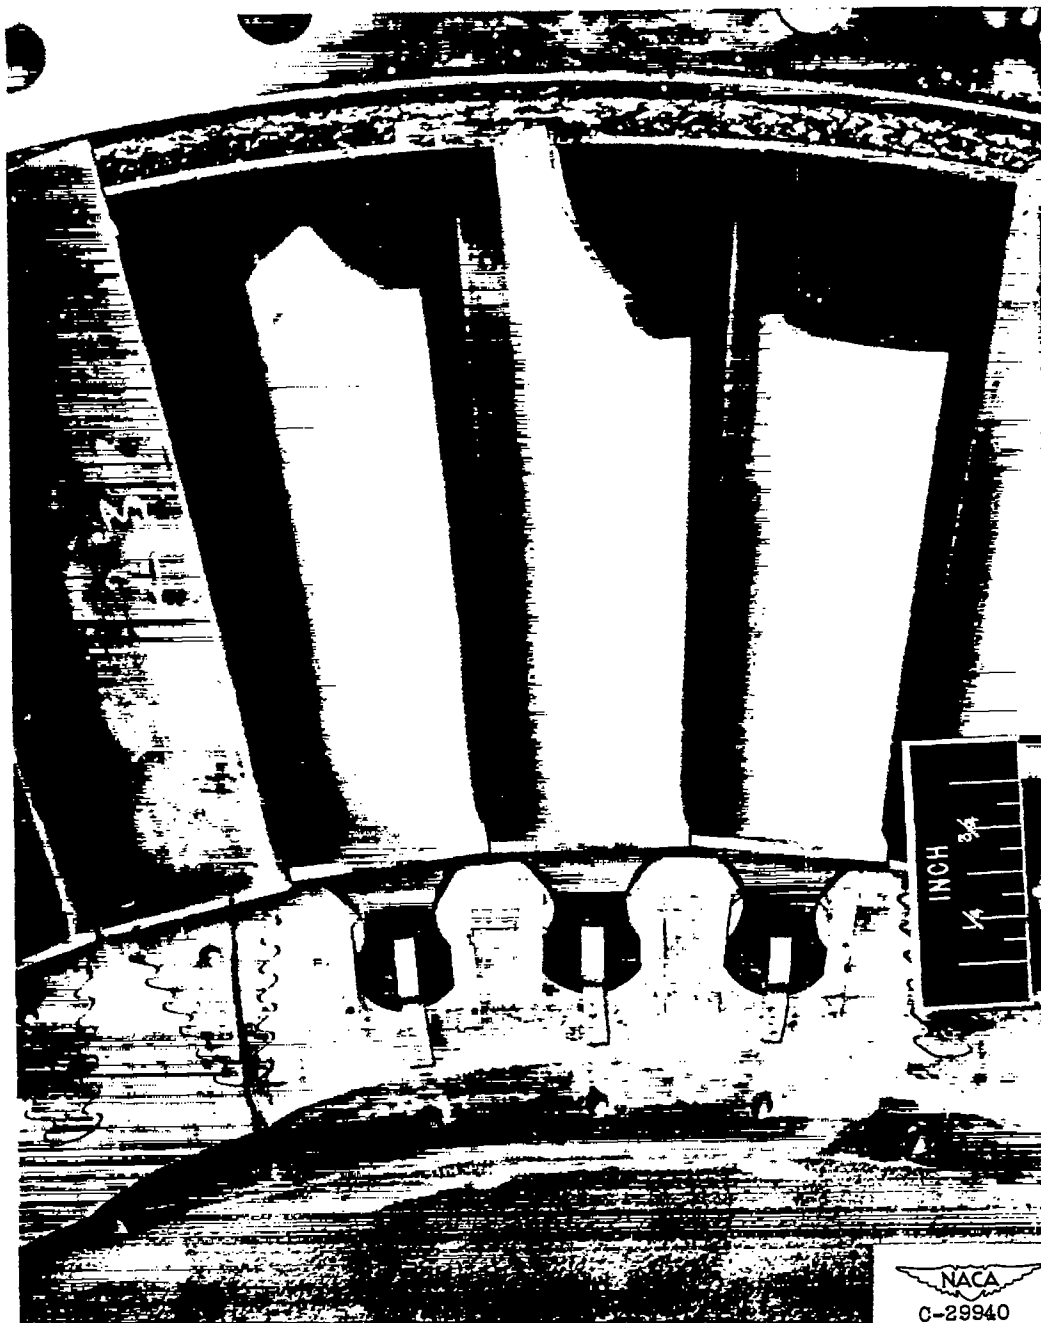
Run 11A. - Because the apparent damage to the other cermet blades in run 11 was very slight, and after penetrant-oil inspection indicated that these blades were still sound, the failed blade was replaced and the wheel was rebalanced. This assembly did not attain rated speed but failure occurred in the airfoil during acceleration at 50 rpm below rated speed. Possibly the failure resulted from a defect in the previously used blades which was not detected during inspection. The broken cermet airfoils are shown in figure 3.

Figure 3. - Airfoil failures in run 11A.

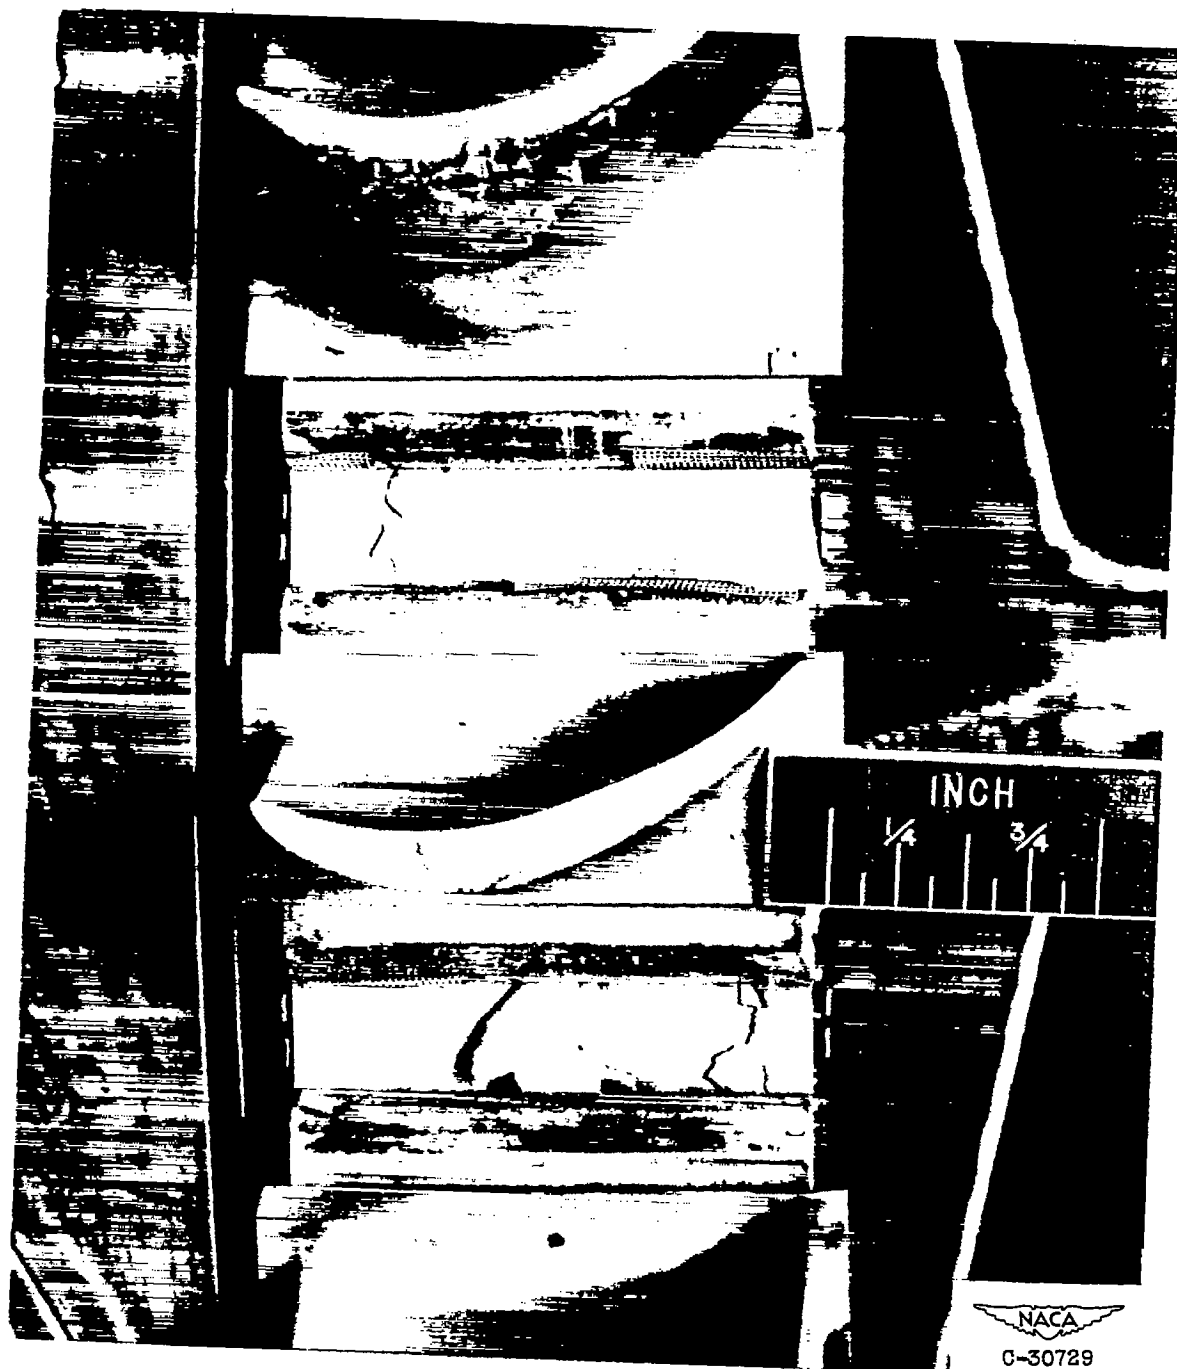
Figure 7. - Fracture surfaces of dovetail roots; run 15.

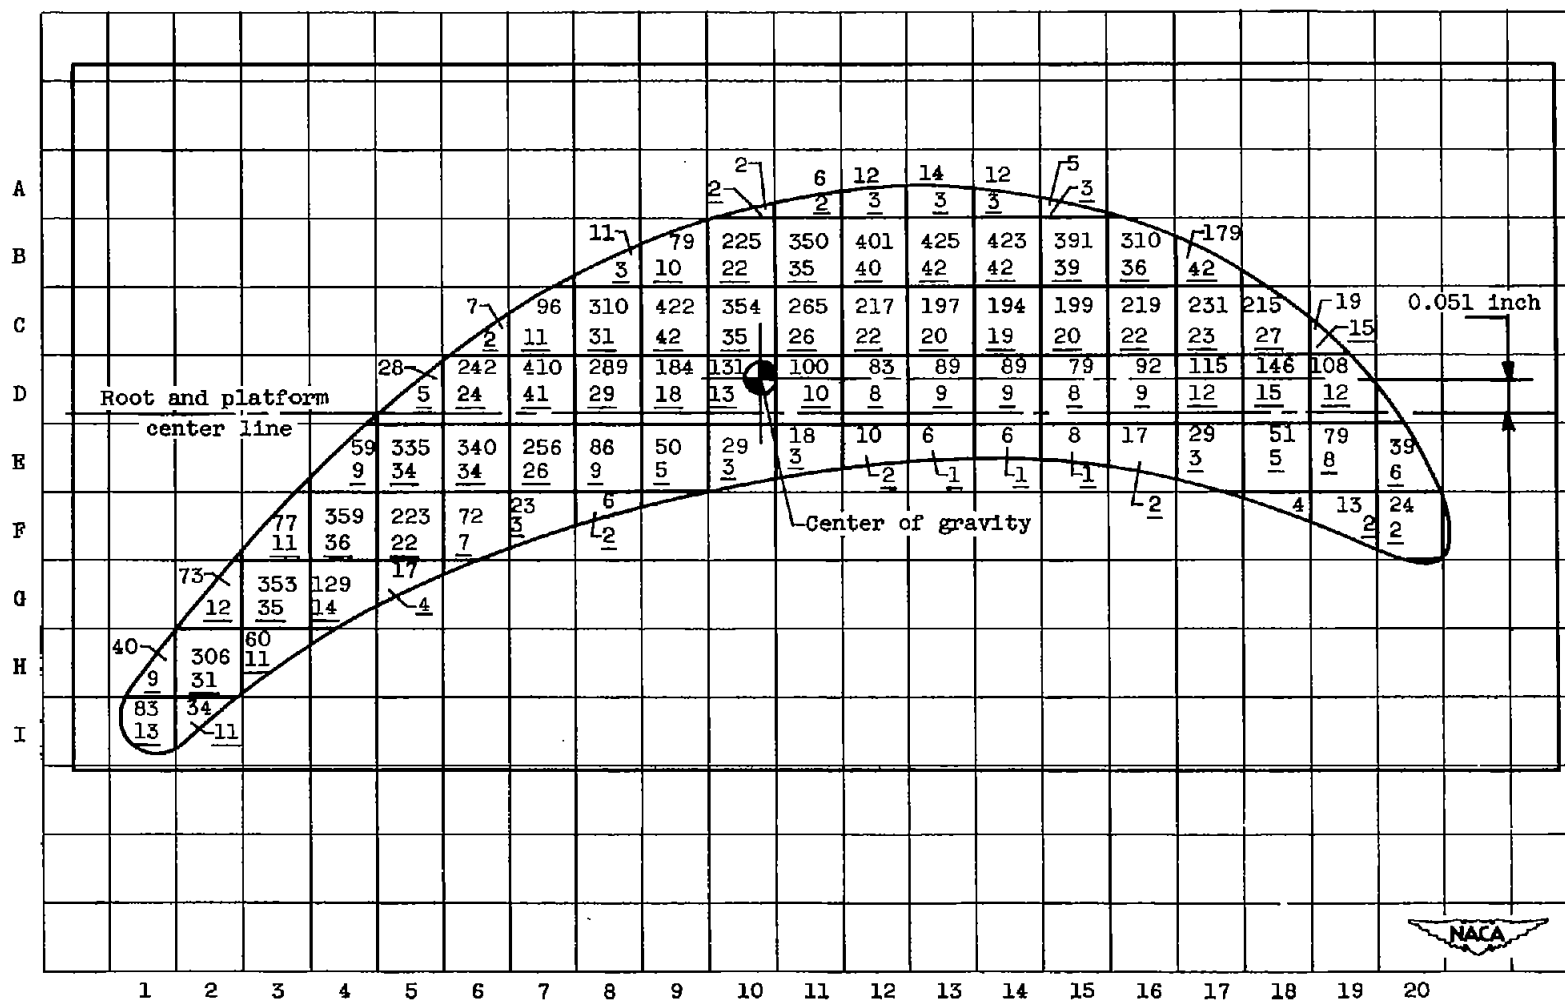
Results of calculation. - The results of the calculations are shown in figure 10. The upper numbers in each square are the total centrifugal forces in pounds acting on each square and the lower numbers (underscored) are the stresses (in 1000-psi units) that would be acting on the base plane squares if each column were cut free from its neighbors. Actually, there would be a gradual variation in stress from one square to the next. From the magnitude of the numbers presented and their location, it is obvious that the greatest centrifugal loads and stresses are in the region where most of the failures originated. The location of the radial projection of the center of gravity of the whole airfoil is determined by dividing the summation of moments of the centrifugal force of the individual columns times their distance from an arbitrary axis by the summation of the centrifugal forces.

Effect of offset center of gravity. - The procedure described shows the projection of the center of gravity on the base plane to be displaced 0.051 inch in the direction of rotation from the center line of the blade platform and root. This offset introduces a sizable bending moment in the blade root which is only partly compensated for by the gas forces on the airfoil. The gas force per blade as determined in the appendix of this report is 100 pounds at rated speed and

Figure 10. - Centrifugal force and stress distribution at base cross-section of airfoil.

The bending stress resulting from this computation is ± 6990 pounds per square inch. If then the airfoil is shifted 328 divided by 11,300, or 0.029 inch, in the tangential direction toward the concaved or pressure side of the blade, this bending stress can be virtually eliminated.

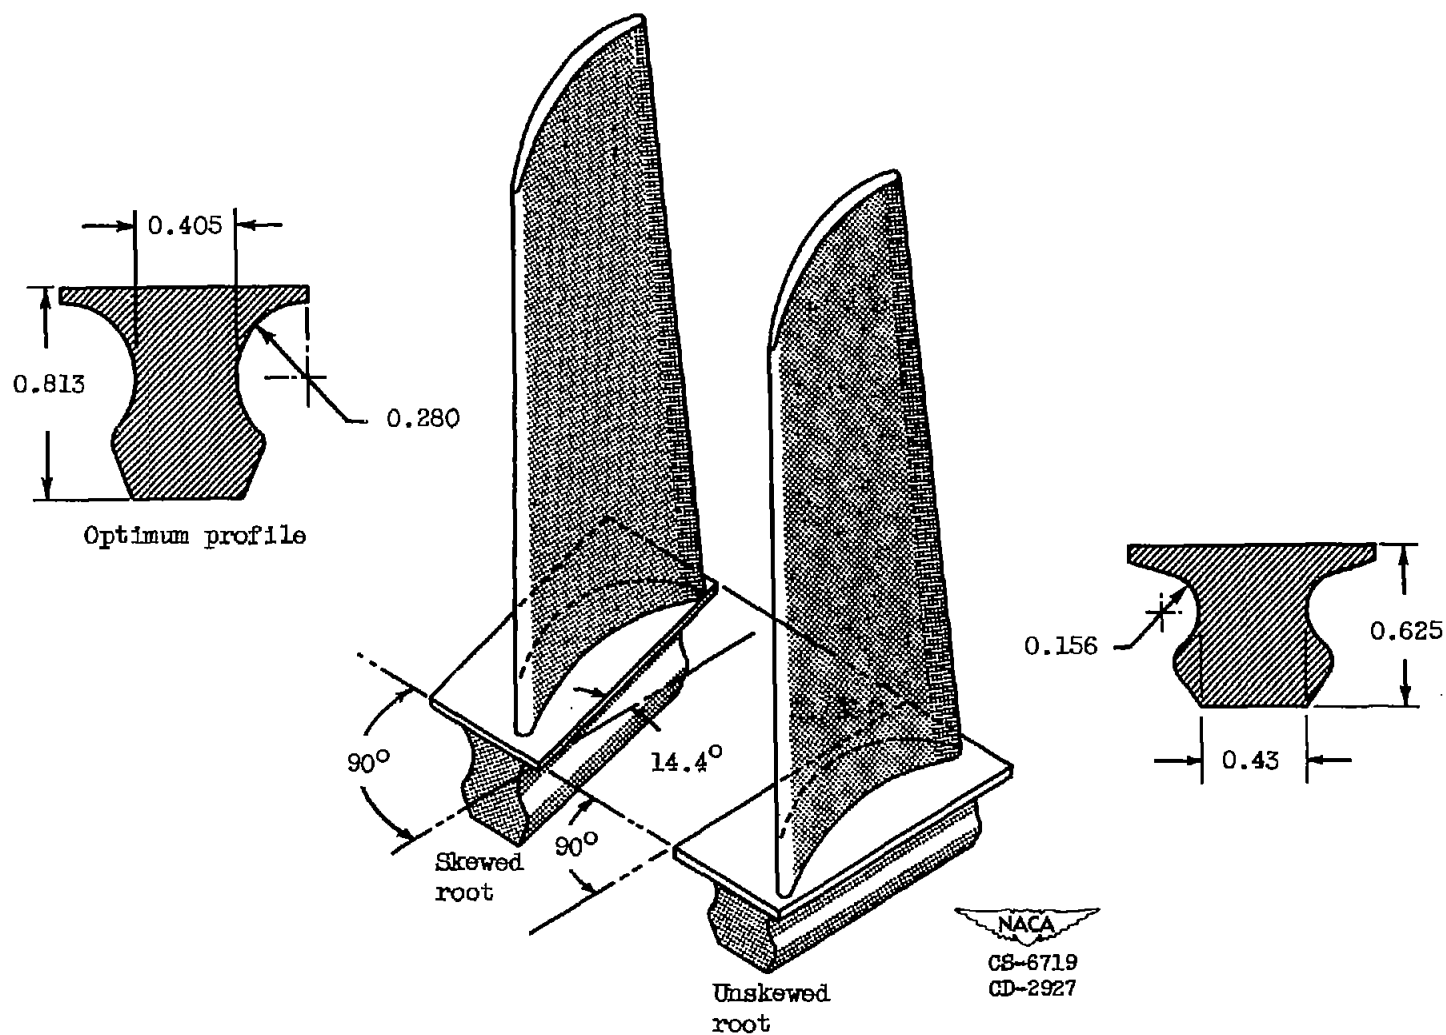
Figure 12. - Dimensions of standard and skewed dovetail cermet blades. (All dimensions are in inches.)

The results of a separate investigation on root profile design are reported in reference 2. In this reference optimum root proportions were determined to give maximum strength in pure tension. The experimental failure load for the small-radius dovetail profile is 37,190 pounds. When the optimum proportions of reference 2 are used, the same load is 41,220 pounds, or an improvement of 11 percent, as established by tensile tests of cermet specimens at 1200° F, reference 4. The increase was caused by a decreased stress concentration factor resulting from increasing the notch radius in the root from 0.156 inch to 0.280 inch. The neck distance in the root had to be reduced from 0.438 inch to 0.405 inch to accommodate the larger-radius root; nevertheless, it is stronger as a result of the lower stress concentration factor. The new root including both the skewing and the new profile is sketched along with the earlier dovetail for comparison in figure 12.

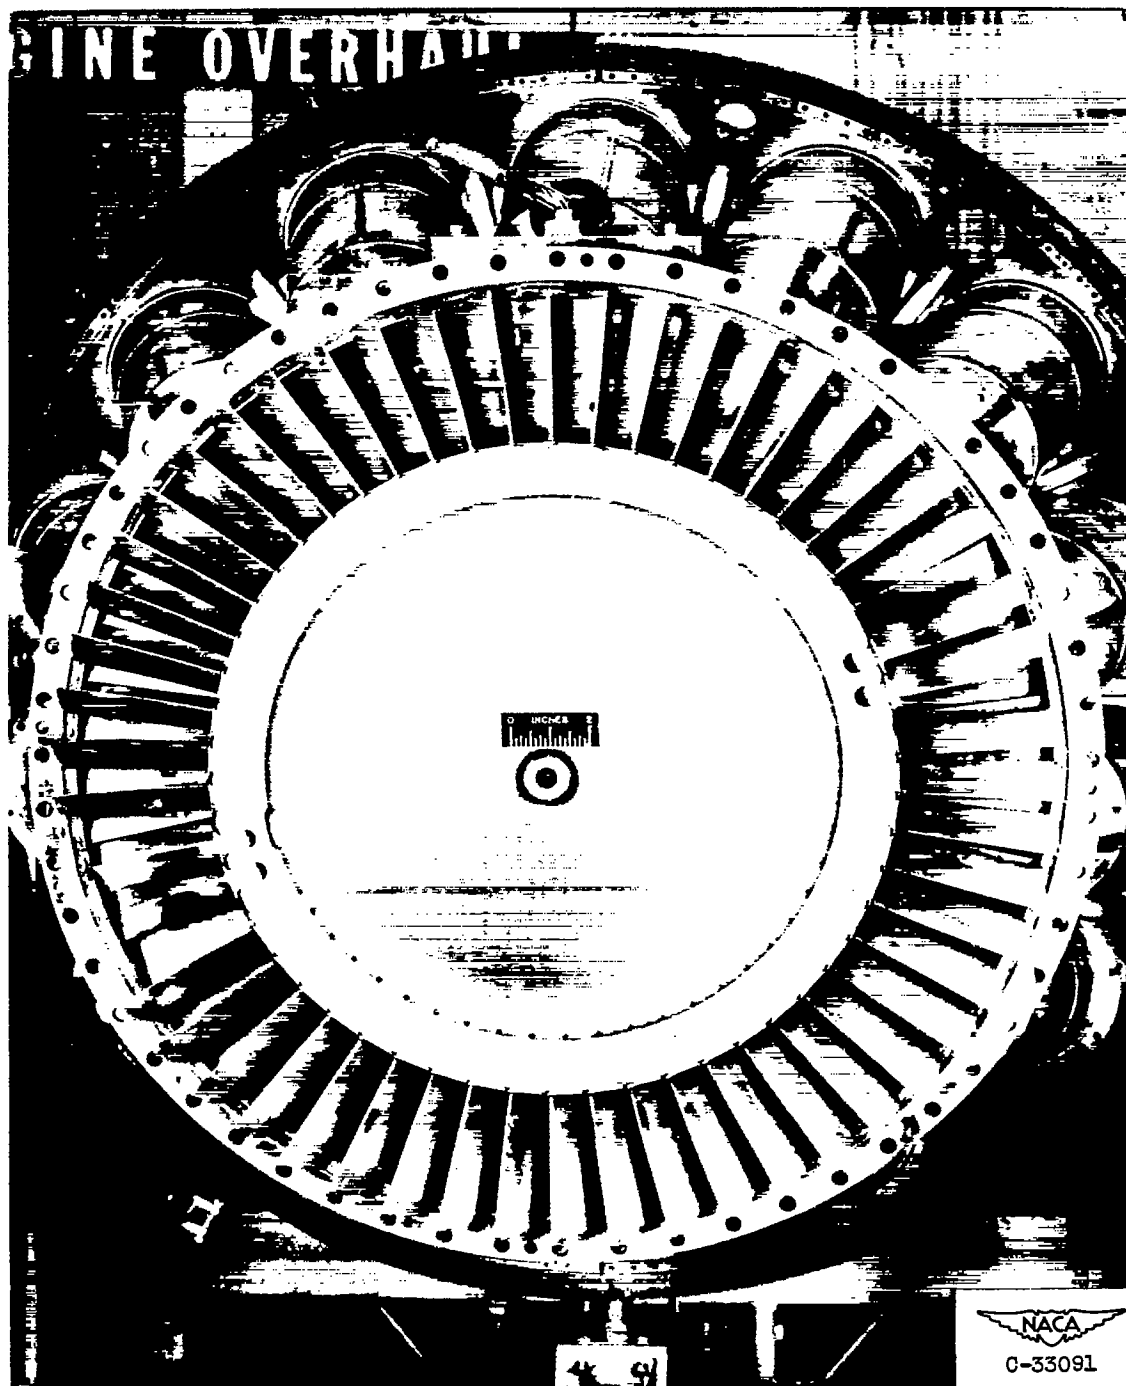
Run 17. - To evaluate the foregoing hypothesis concerning notch radii differences, four skewed-root blades were inserted in a new turbine wheel, two of the large-radius profile on one side of the wheel and two of the small-radius profile on the diametrically opposite side. The intention in run 17 was to run the engine 50 hours at rated speed and power (closed tail cone) and then proceed with cyclic operation. The engine ran 36 hours before the blades were damaged (fig. 17)

as a result of fatigued fragments breaking loose from the combustion domes and liners and passing through the turbine. Even though no cyclic operation was obtained to evaluate the effect of thermal expansion and contraction on the different radii, sufficient operating time was obtained at full power to indicate that probably the displacing and skewing of the root, and not the change in profile, were the primary factors leading to increased blade life.

Figure 17. - Failure of airfoils resulting from fatigue of combustion domes and liners; run 17.
